MAXEY FLATS: PUBLIC MEETING AND TOUR

May 31, 2002
Environmental Quality Commission

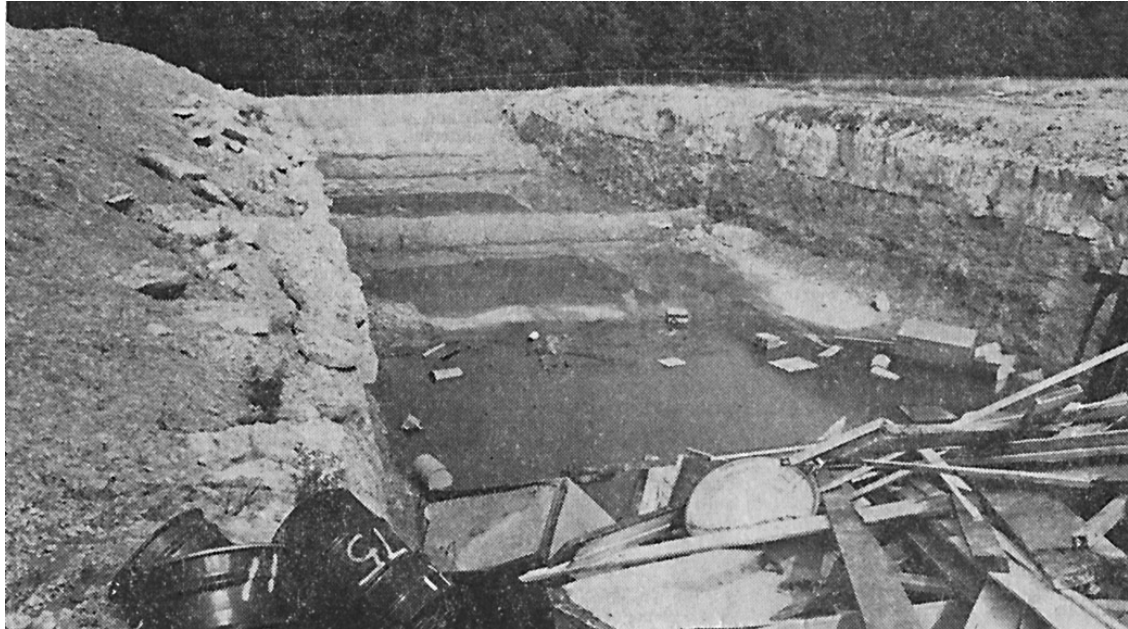
One of the 46
unlined burial
trenches at
Maxey Flats
Low-Level
Radioactive
Waste site.
1975 photo -
The Courier-
Journal and
Times

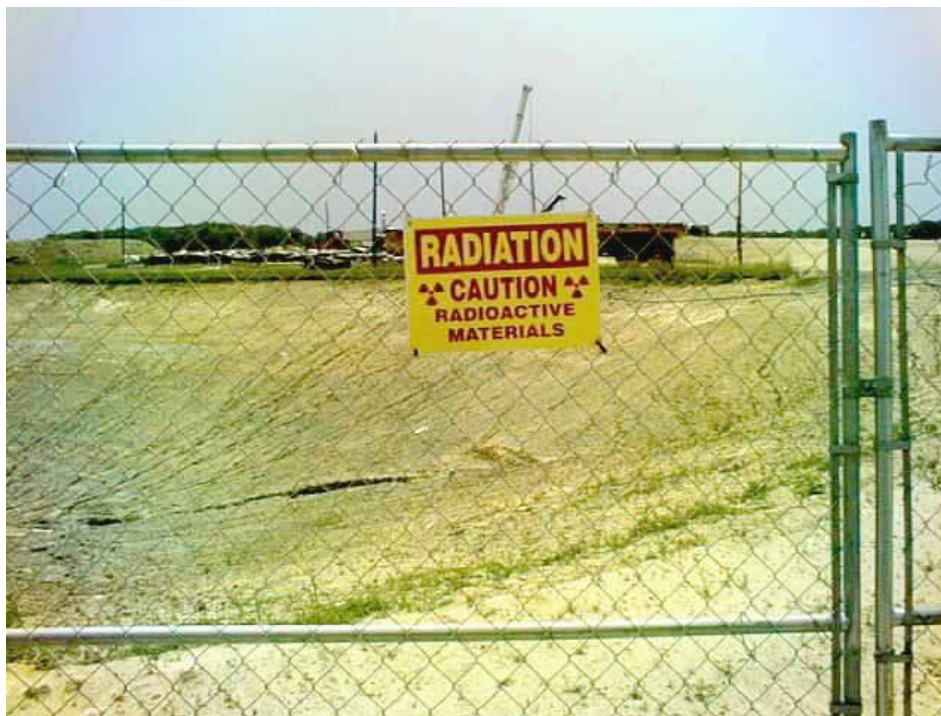
A fence will be built around the perimeter of the 60-acre "Restricted Area." EQC expressed concern about public access to the site and its 537 acre buffer zone. No warning signs are planned in the buffer zone and no guard is on duty.

- A fire protection plan for the site and the adjoining forestland be prepared.
- An emergency response plan for the site be prepared.
- The state take the steps necessary to limit public access to the 900-acre site and prevent vandalism.

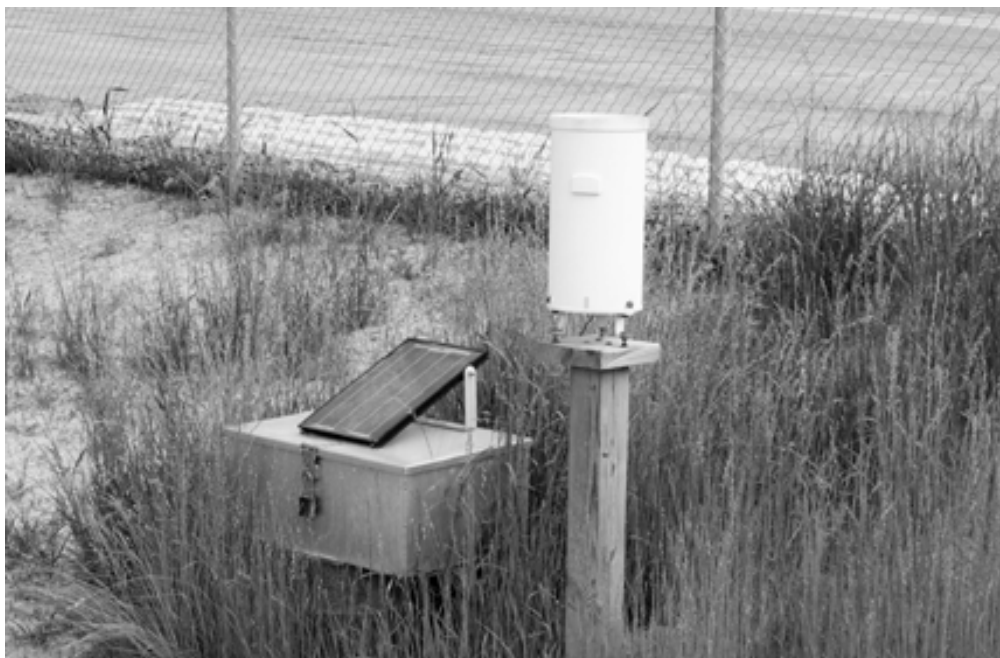
One of 24
solar-powered
groundwater
monitoring
wells around
the site. The
principal
pollutant
detected in
groundwater
is radioactive
tritium.

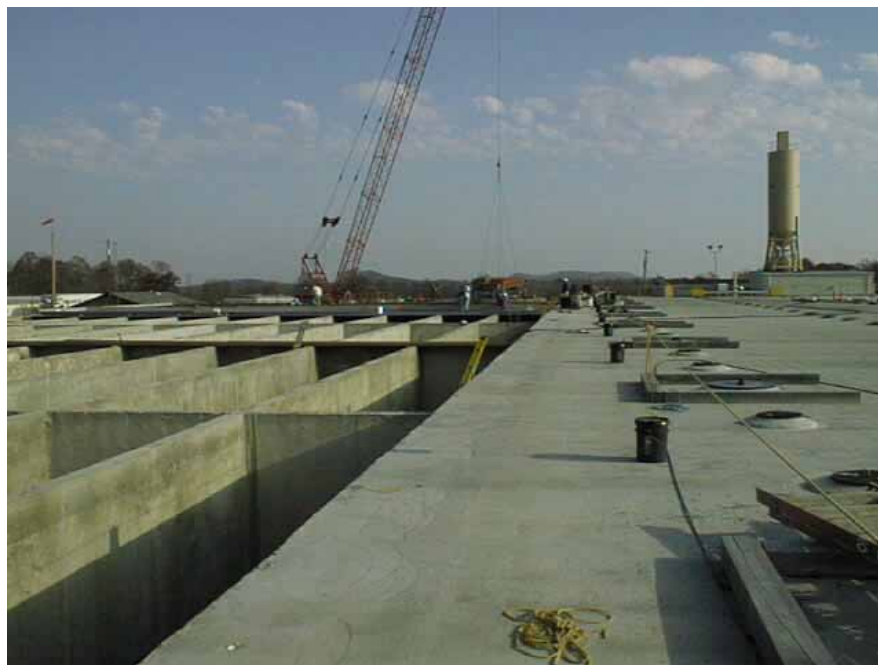
Part of the remedy at Maxey Flats included removing radioactive leachate from the disposal trenches. The waste was solidified and disposed of in concrete bunkers constructed at the site (1999 photo).

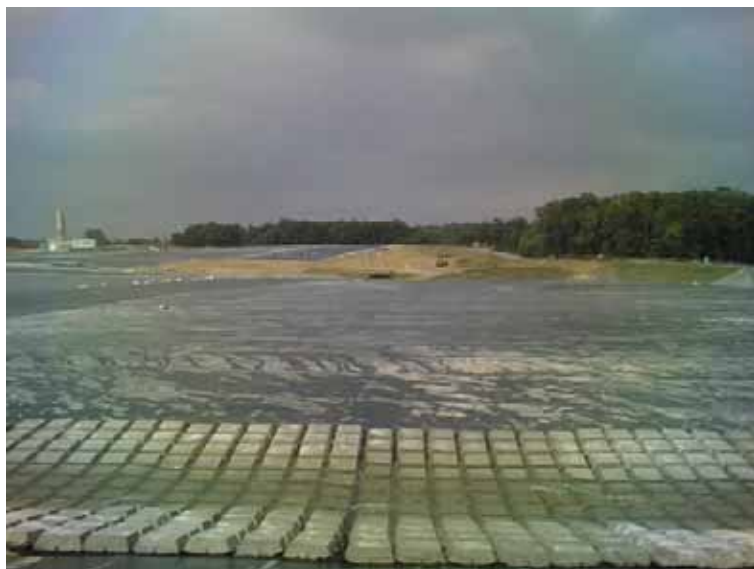
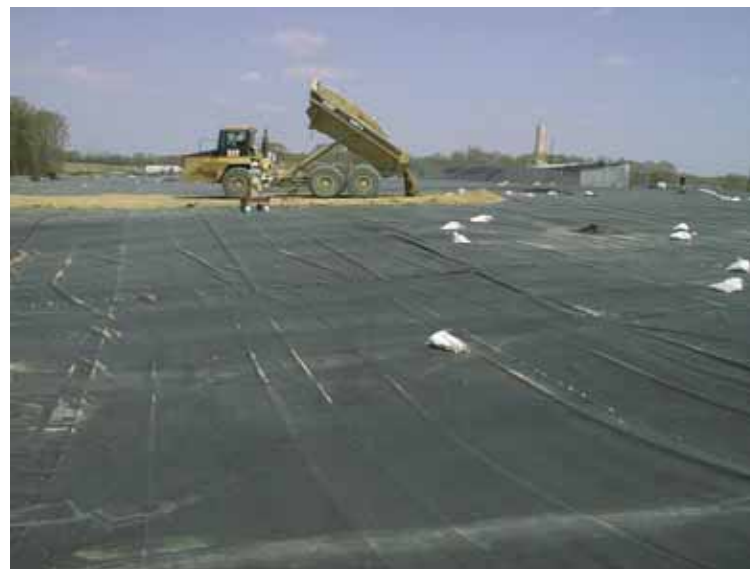
A 60-acre synthetic cap is currently being constructed over the site. The cap should last 20 years. Articulated block has been placed in drainage areas to slow down water running off the site. A final cap will be constructed in 100 years.

Construction of a 60-acre synthetic interim cap and associated surface water and erosion controls is currently underway at the **Maxey Flats** Superfund site. These construction efforts are scheduled to be completed by the end of 2002. Following completion, the Commonwealth of Kentucky will implement an extended maintenance plan that may last up to 100 years to allow natural stabilization before a final cap is constructed. Responsible parties will be required to address any problems found at the site during the next 10 years. In 2012 site maintenance, monitoring and institutional controls will be the sole responsibility of the Commonwealth of Kentucky in perpetuity. The U.S. EPA will hold a public meeting and tour of the site in the fall of 2002. For more information about the meeting contact Derek Matory, U.S. EPA, 404-562-8800, email - matory.derek@epa.gov

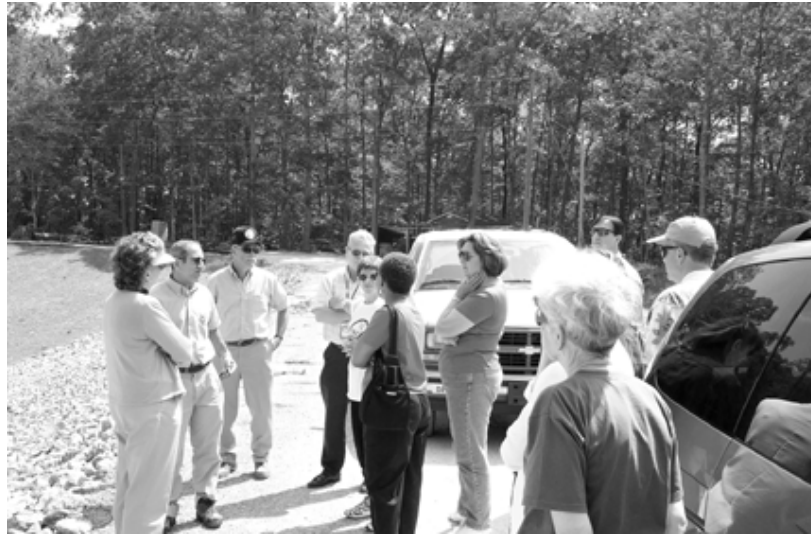
EQC Commissioners toured the Maxey Flats site. Several recommendations were made including the need to test fish in nearby streams for radionuclides.

- Fish tissue testing for radionuclides be conducted by the state in Rock Lick Creek, Drip Springs, Fox Creek and Licking River and the results of this testing be provided to the public.
